Seismic Effects on the Stone Masonry of Rubik Church in Albania: Interaction Modeling of Different Masonry Panel Types

Abstract

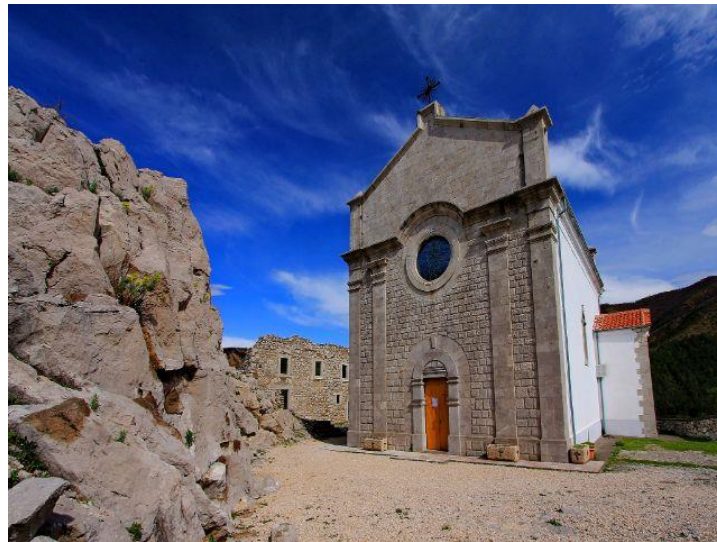
Fig. 1: The facade of the church's main entrance
Source: Albanian Government Council of Ministers (2021)

The church monastery of Shelbuen Rubik is situated about 70 km north of Tirana above a very steep rocky hill. The monastery church has been referred to as a Benedictine abbey since 1166, and old mosaics trace Latin inscriptions dating back to 1272. A single-nave church, oriented along the axes, East (apse) and West (main entrance). It is attributed to the Norman style, making it one of the few surviving cultural monuments of this style in Albania (Fig. 1).

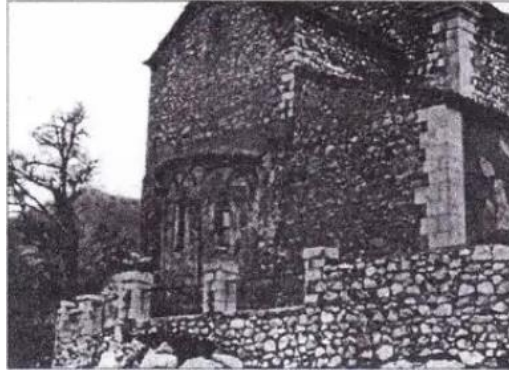
Fig. 2: Image of the church (XIX century)
Source: Hoxha (2016)

The church is a stone building with stone walls. The masonry preserved from different times and typologies differs throughout the structure. The oldest preserved part is the apse walls, built almost horizontally from irregularly shaped stones joined by a lime mortar. The wall on the West side was torn down to create a connection to the new nave of the church, which was realized through a stone arch supported by stone columns. This rebuilding was done in the middle of the nineteenth century (Fig. 2).

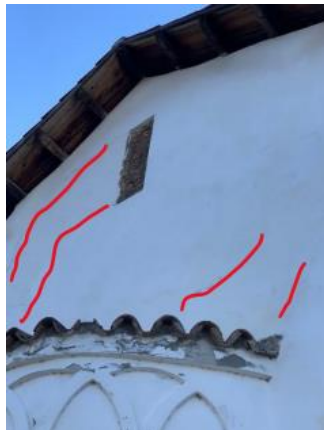
The earthquake that occurred on 26 November 2019 in Albania near the small town of Mamurras is the first documented seismic event to cause damage to a monastery. Structural damage is usually of two types: degradation/damage to materials and some minor structural damage (Eremenko et al., 2020). The condition of the church as it stands has now been documented by non-destructive testing and visual observation. From these investigations of the church structure, the problems can be summarized: Structural damage includes cracks in the face (Figs 3 & 4) and the vault of the apse (Fig. 5), damage and cracked masonry in the oldest part of the church – the closing wall of the east side above the apse.

Fig. 3: Cracked masonry wall above the apse
Source: Author

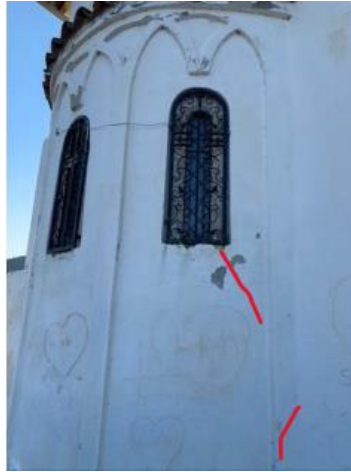
Fig. 4: Micro cracks in the wall of the apse
Source: Author

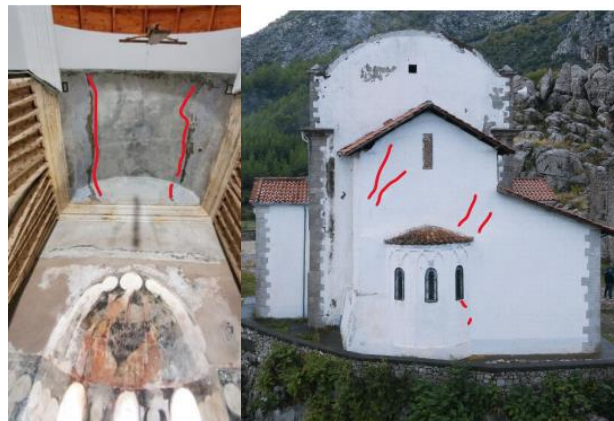
Fig. 5: Cracks in the vault of the apse and the wall
Source: photos were taken by the author

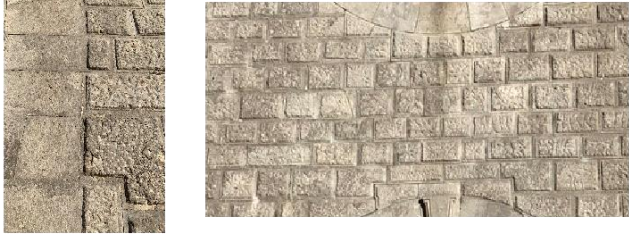
WALL QUALITY INDEX EVALUATION (IQM)										M-01

No changes in height depending on the structural elements were noted. Once the measurements are taken, from a geometric point of view, it can be assumed that there is complete accurate information about the structure of the building. By examining the documented data and taking into account the studies carried out by the Monument Institute of Albania (destructive tests exclusively for mortars), 5 types of wall panels have been defined (Albanian Government Council of Ministers, 2021). For each of them, an index of masonry quality (IQM) is determined, strength parameters are estimated by empirical and correlation tests, and acoustic stiffness is evaluated by acoustic tests. The table below shows the parameters of each type of masonry panel (Table 1) and the information for the IQM of the facade wall (M1) (Fig. 10).

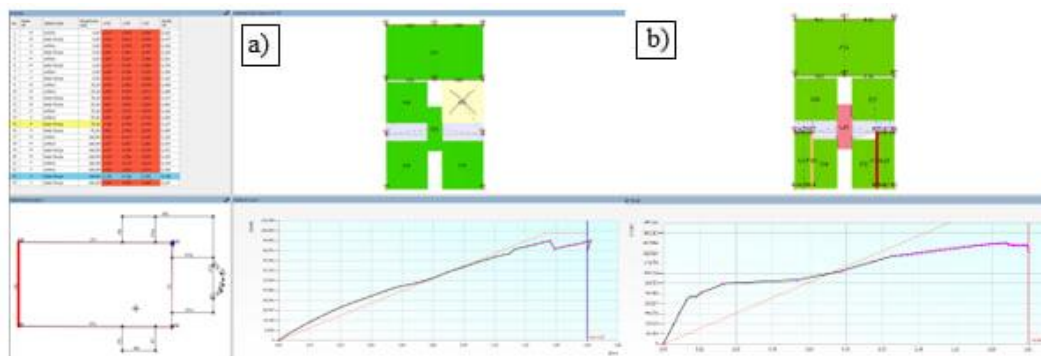
Fig. 18: Two-dimensional view of the load-bearing capacity analysis curve. The position of the panel and the nature of its behavior. (Wall at the main facade, M1): a) without local interaction; b) with local interaction
Source: Author
