# Heritage Buildings and Land Subsidence in Semarang, Indonesia

This study uses old photos of a heritage building to compare the original architectural sizes with the latest conditions and. It also employs the data taken from the excavation of the building renovation project.

Findings show that the original floor and toilet levels were located approximately 100 cm under the present levels. The rate of land subsidence resolved from this analysis is about 3.3 cm/year. This rate is commensurate with the figures of the land subsidence map produced using geospatial data. The architectural approach demonstrated in this study could become a complement tool to investigate the subsidence phenomenon.

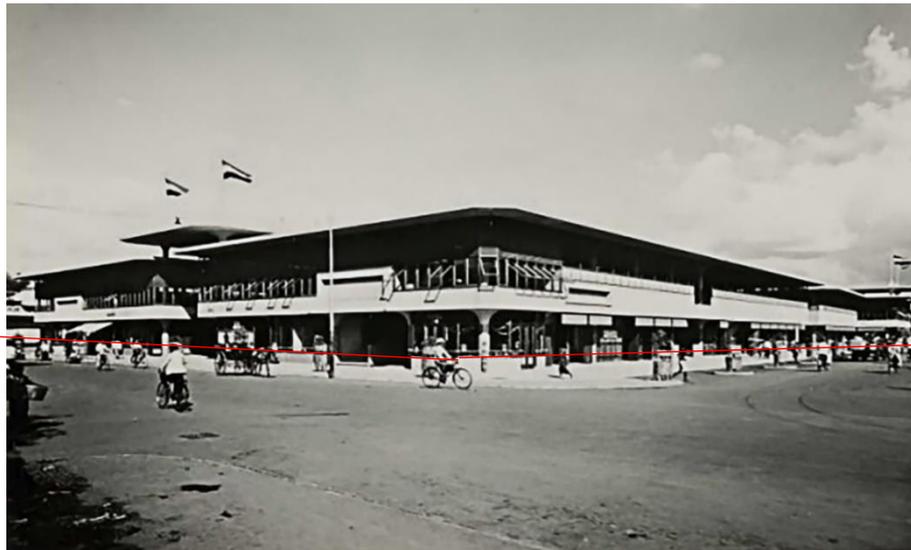
The red line shows the current position of the building relative to the road.

**Fig. 3 :** Photos of the old Johar market which will be compared with the latest condition  
Source: Anonym, 1938

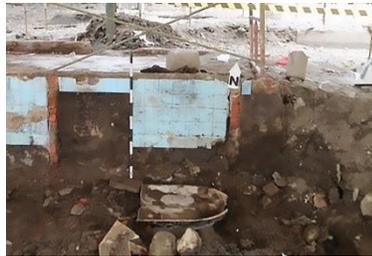
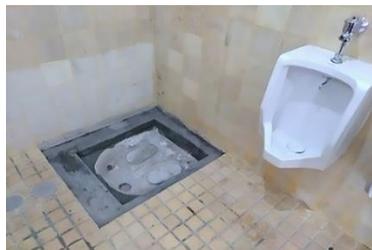
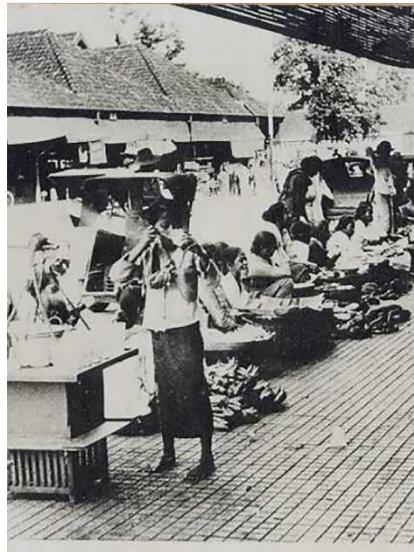
(a)

The Government and the Ministry of Public Works and Public Housing (the ministry of Pekerjaan Umum dan Perumahan Rakyat/ PUPR) carried out revitalization activities in order to improve the condition of Johar market due to tidal floods and fires in 2015. The Ministry of PUPR carried out the revitalization of the Johar market Semarang cultural heritage in the central and northern parts of the market with a construction contract value of Rp. 146.09 billion with the contractor PT Nindya Karya. The work carried out included rehabilitation of buildings, curved roof trusses, mechanical, electrical installation, paving installation, installation of tiles for meat sellers, painting of stall table frames, and construction of drainage control tanks. The development also included complete facilities, especially in the aspect of security. At the time of construction, there was some photo documentation. When carrying out renovation activities, one of them was the discovery of the original floor in Figure 6. There was a toilet that was suspected to be the original part of the building (Figures 6a, b and c). The toilet floor have small squares pattern. It is the original floor of the building. Photos from building excavations also shows the old floor position about 100-120 cm from the present floor.

It is worth noting that old photos from the KITLV, a website containing various old Dutch colonial photographs, have revealed additional evidence of the Johar market conditions during the colonial era. The pictures show that numerous traders were conducting business in the area. One photo in particular displays a floor with the same small square pattern as the one seen in figure 6b and c. It is suspected that the original floor may have been covered with a new one, and the elevation of the floor was likely done to avoid tidal flooding. Raising the floor was the most efficient way to prevent tidal flood from entering the building, and was achieved by elevating the building higher than the level of the road. As a result, the elevation of the floor to avoid the tidal flooding has caused the building to appear shorter than its original condition.
