Enhancing Pedestrian Safety from Traffic Accidents at the Jadiriya Complex within the University of Baghdad, Iraq

Suhaib M.J. Al-Ahbabi & Hoda A.S. Al-Alwan

Department of Architecture Engineering, College of Engineering,
University of Baghdad, Baghdad, Iraq.

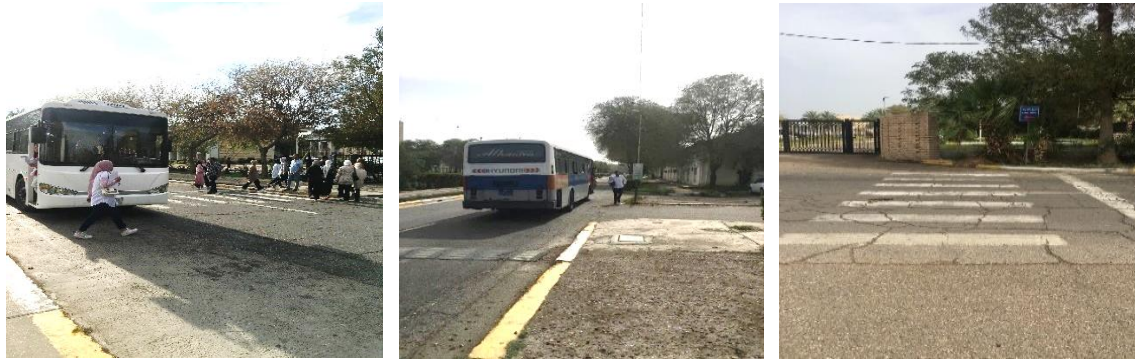
Fig. 3: Insufficiency of planned pedestrian crossing corridors.

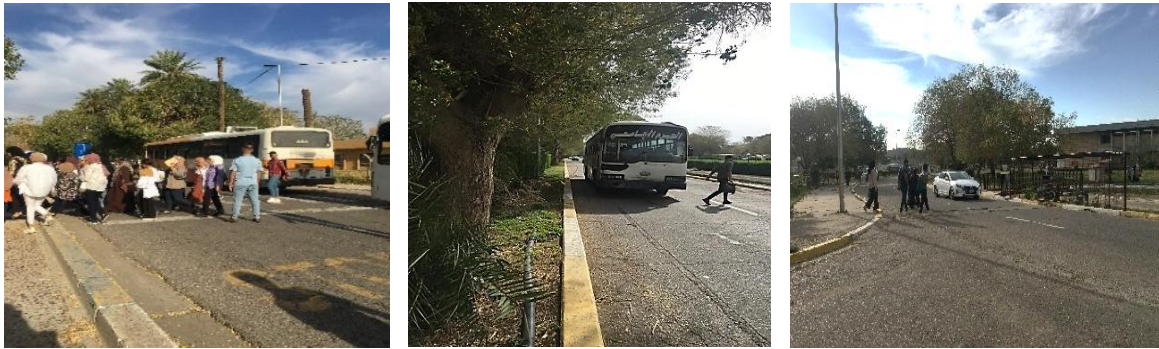
Fig. 4: Pedestrians crossing from areas at random.

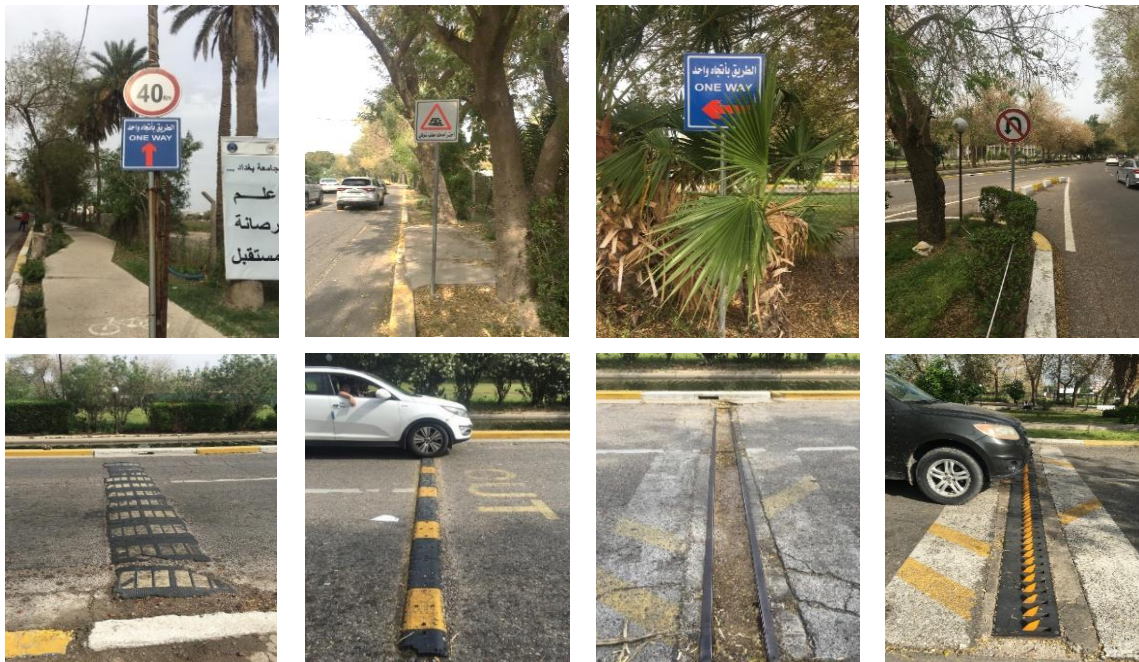
Fig. 6: Poor visibility of traffic signs and speed reduction humps.

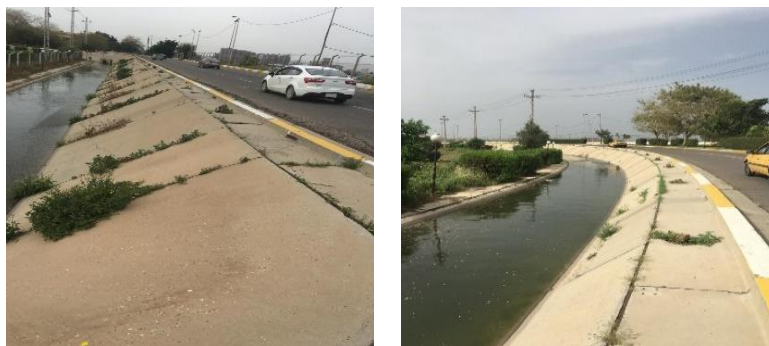
It was also noted that the level of the ring road surrounding the study area is 3 meters higher than the surface of the aqueduct adjacent to it. It was also noted the trees planted between those roads and the aqueduct have been cut. There is also an absence of any fence to protect cars from falling into the canal, especially at high speeds exceeding 90 km/h (Figs. 5& 7). The officials pointed out that these have been done to offer clear visibility. Fences have not been erected because of the lack of financial allocations.

Fig. 7: The level of the ring road to more than 3 m from the adjacent canal.

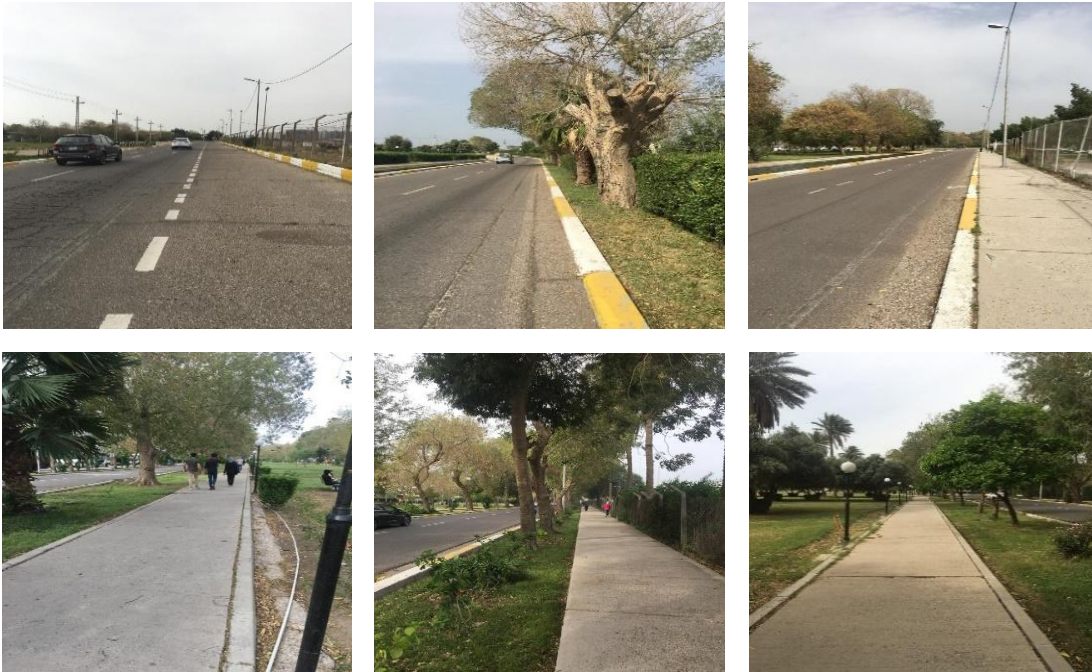
It is noted that there is a clear separation distance between the pedestrian walkways and the car paths. Walkways are planted with trees with a width ranging from 2 m to 2.8 m, which enhances walking in a safe environment. It also protects them from weather conditions due to the natural shading of trees. In other areas however, pedestrian walkways do not exist (Fig. 8). This is one of the causes of traffic accidents because the separation distance between lanes and roads enhances the feeling of protection for the pedestrians. It also forms a barrier against the cars.

Fig. 8: Separation distance and the areas where pedestrian walkways have been canceled.

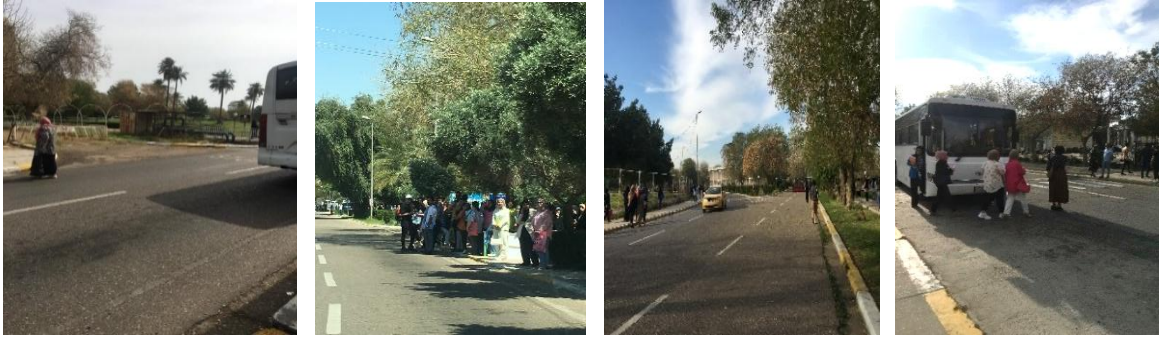
Visual monitoring recorded the following Improper behavior of pedestrians (Fig. 9).

1. Walking within car routes.
2. Crossing those roads suddenly.
3. Non-compliance with traffic signs.
4. Parking within certain parts of roads such as waiting for places for public transport buses.
5. Indifference to the movement of cars on the roads assigned to them.
6. Crossing in front of public transport buses and not behind them.

Fig. 9: Bad behavior of the pedestrians.
