Using Architectural Stratigraphic Surveys to Study Historical Buildings: An Illustration through El Mechouar-Tlemcen, Algeria

Zahira Seddiki¹ and Massouad Aiche²

Abstract

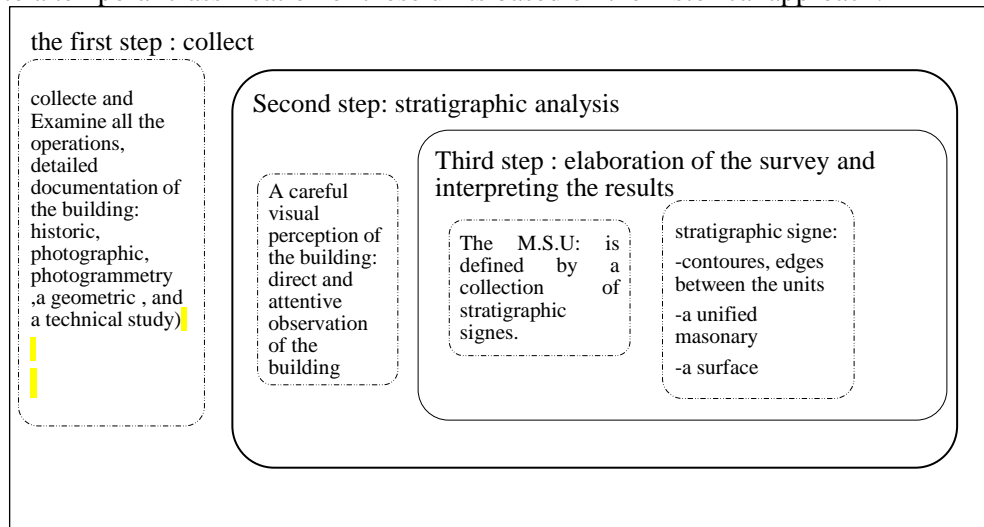
Scheme 1: The operational methodology of the stratigraphic analysis

According to Harris, Brogiolo and Francovich (Edward, 2014c), stratigraphic analysis of monuments takes place according to different consecutive phases which can be presented in the scheme below (see scheme.1). The first step includes the collection of all the information related to the history of the building. The second step identifies the masonry stratigraphic units, which were exposed in the building or photogrammetry surveys of the building state before and after intervention. The masonry stratigraphic unit identification is based on the masonry visual

perception which permits the division of stonework into units of scars areas (the contours, edges and boundaries of the different stratigraphic units), corresponding to units of intervention. Then, it resorts to a temporal classification of these units based on the historical approach.

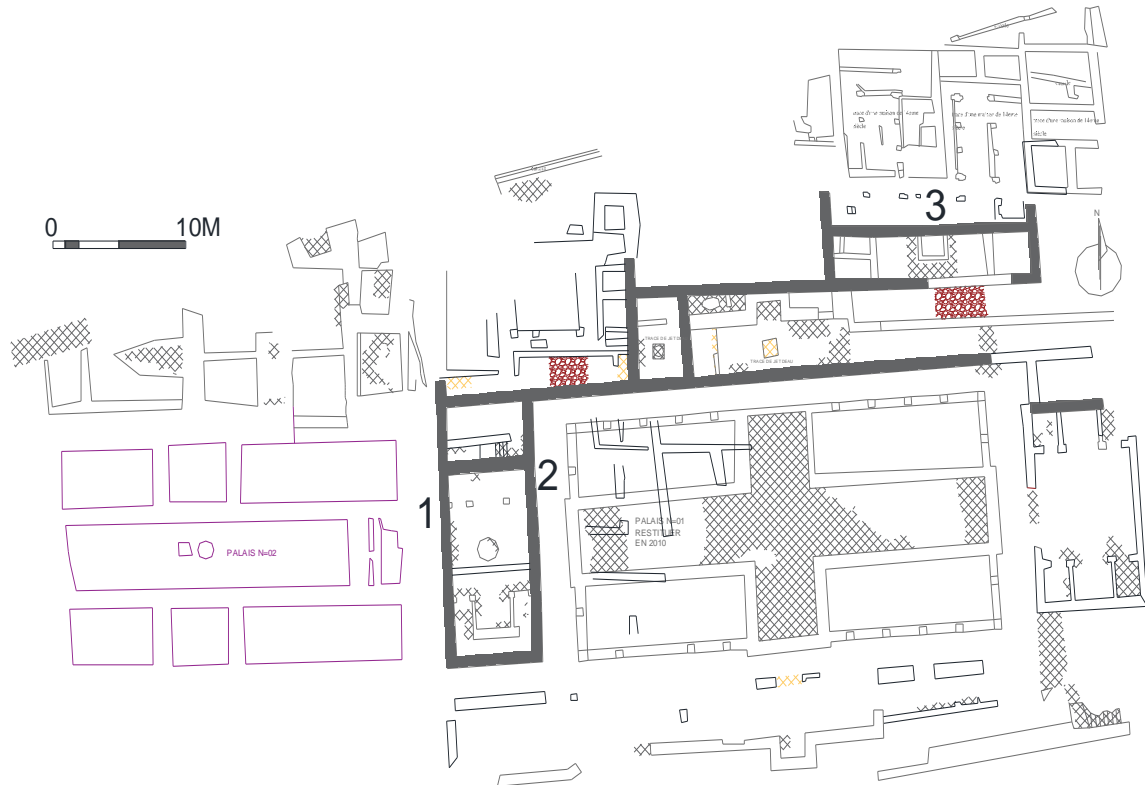
Fig. 3: Plan of the synchronic stratigraphic survey, of the El Mechouar Palace in 2009.

Stratigraphic units at site plan level

MSU corresponds to the palace walls dating dating back to the 13th-14th century with modification dating to the Ottoman and french colonial period
-

MSU defines the traces of the palace walls dating back to the 13th-14th century
-

MSU defines the traces of the palace walls dating back to an unknown period. Now it is buried
-

MSU defines the traces of the walls of the palace dating back to the 17th century demolished during the restoration of the palace
-

MSU corresponds to zelijdj dating back to the 13th-14th century
-

MSU translates the restoration work of the zelijdj dating back to the 17th century
-

MSU translates the paving stone dating back to the 19th century

1 | 2 | 3 correspond to walls will be analysed in elevation

The palace consists of a number of rooms, which are located throughout four sides of a large patio (Fig.3). They are large multifunctional rooms and anterooms. “This common characteristic has been denoted by Georges Marçais between the case study (the Mechouar) and the small Partal Palace (the Alhambra)” (Kasmi & Aiche, 2016).

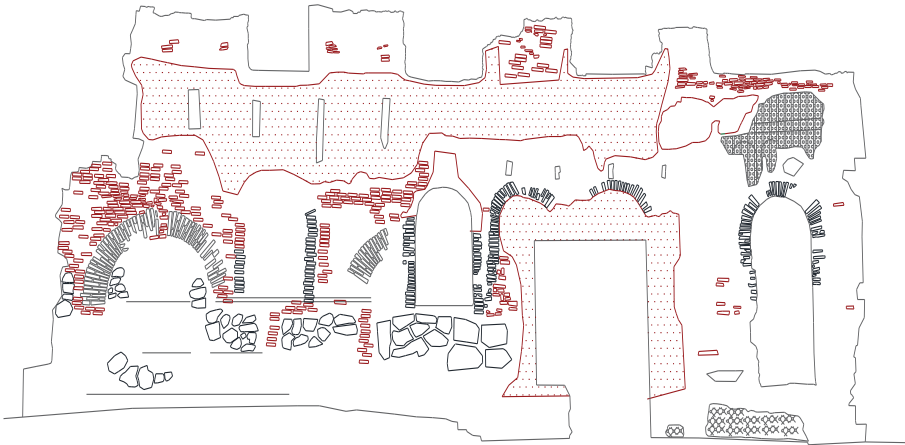
Fig. 4: An elevated view of synchronic stratigraphic records of El Mechouar palace in 2009
Source: authors

MSU corresponds to the brick dating back to the 13th century.
-

MSU corresponds to cob dating back to the 13-14th century
-

MSU defines the zalidj dating back to the 13-14th century.
-

MSU defines stone dating back to 17th century.
-

MSU corresponds to the solid brick-the walls doubled-dating back to the 18th century
-

MSU coated with cement dating back to the 19th century.

The stratigraphic survey (see Fig.4) has revealed a masonry, which is characterized by a general use of cob walls dating back to the 13th -14th centuries, an average height from 1 to 2 floors. It has been noted that the tuff stones dating back to the 17th century have replaced the

damaged cob. It also indicates the fall of the wall covering and ornaments. This period marks a reuse of the old walls, which have witnessed a time of abundance. The destroyed place has been reconstructed after the uprising of the parish in “1670” (Quetin, 1848) by Bey Hassan who won the war.

The opening system has changed its shape through three different eras. During the first era, the building consisted of semi-circular arch openings of solid brick, which were filled later with cob, and solid brick. The building during this era is probably part of an earlier construction, which was preceded by the construction of the palace in 1235 when the Zianide kingdom was founded. The openings are limited to 2.5 meters in height and 2.2 meters in width. During the second era, the opening system was characterized by a multiplication of openings that make up the exterior and interior facades. It was also characterized by a perfect symmetry provided by a rhythm of the opening that causes a radical change in dimensions (doors 3.2 meters high, the spandrel window wall is 1.8 meter that prevent the view). These transformations, probably Ottoman, constitute a passage from a palatial architecture to a domestic architecture and from ornamentation to austerity. The creation of the rooms in the patio evoked this aspect (Fig.5). However, they preserved the *zellige* that covered the ground. During the third era, the opening system was related to the transformations of 1843 under the French occupation. It was characterized by large interior doors, ensuring a better connection between the rooms. The walls were thickened with solid brick. Generally, the work carried out during this time was minimal.

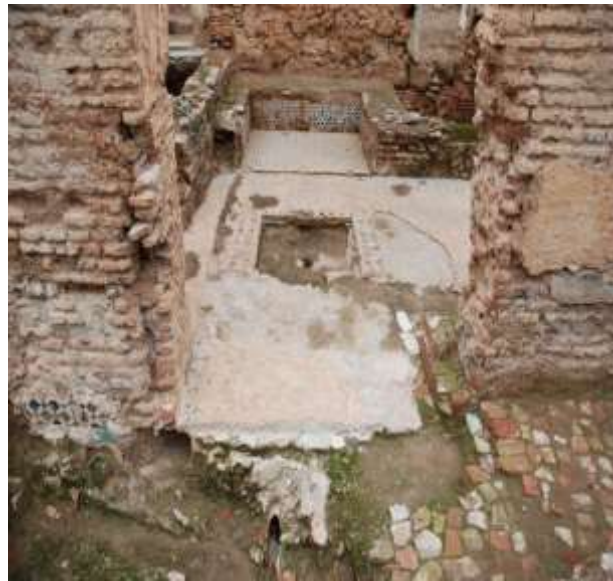
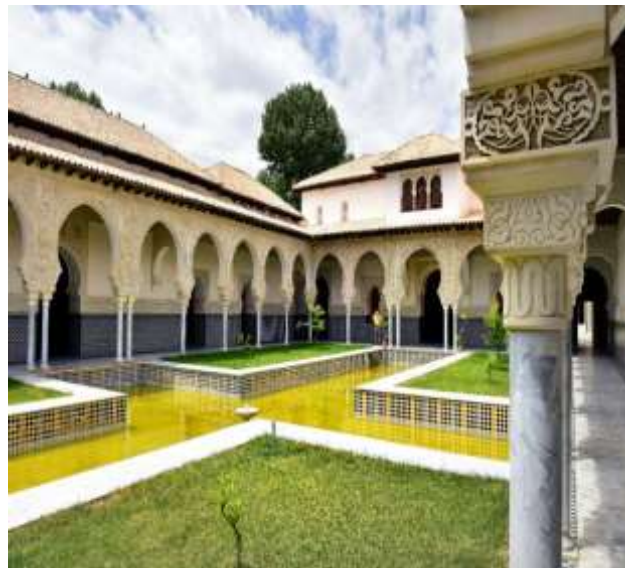
Fig. 6: The condition of the palace before the operation in 2009.

Fig. 6: The palace after the operation in 2009.

The intervention consisted of reconstructing the missing parts (Fig.6) using traditional construction techniques to reconstruct the roof, load-bearing walls, floors, stairs, porticoes, the fountains and the large basin. Likewise, the older walls were subjected to damage mending and consolidation, which integrally reinforced the supporting system and covered the stratigraphic units. A jacketing has been used to consolidate the old foundation into solid brickwork. A restitution of the ornaments comparable to those on the site took place. The distinctiveness was marked by increased thicknesses for the stucco decorations and slight nuances for the *zellige*. “It therefore, in short, possessed an architectural cloning form for therapeutic purposes,
