Housing Practices in Anatolia from the Past to the Present; Traditional Konya Houses

Yavuz Arat

Necmettin Erbakan University, Turkey.

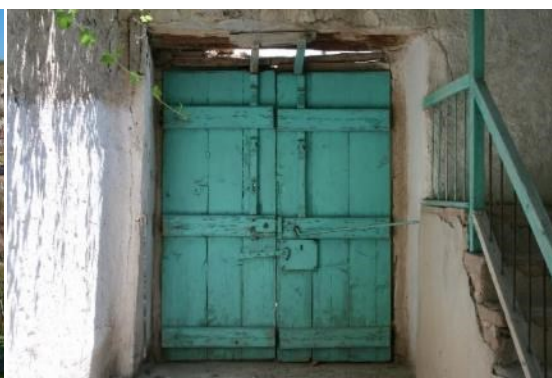
Fig. 4: Konya house courtyard/hayat gate
Source: Author

From this point of view, in traditional houses shaped by cultural codes from the past, even if the building material obtained from a widespread hinterland changes, there are no visible changes in the number of storeys and shaping in the plan scheme. In certain neighborhoods, such as in front of the tomb (around Mevlana tomb), where the housing texture shaped on a neighborhood basis is dense, the traditional understanding has continued to be maintained. A large single or double winged door opening to the part used as a road accesses at this point, the high *hayat*/courtyard wall. In this housing pattern, which is generally shaped on the flat plain, the use of storeys has developed in a similar way in this type, and forms of spatial organization have been provided with the orientation of functions and appropriate garden use. In addition to the traditional dwellings of the city, which developed in a plain area, there are also settlements in sloping areas where older settlement forms are seen, where there is a floor or level use below the ground floor level. In this settlement form, there is a formation that allows for the terrain conditions. As an example, in neighborhoods identified with the Neolithic Age, such as the Sille Neighborhood in the Selçuklu district of Konya city, the spatial organizations seen in the houses built were solved with a "slope/level" with a sloping formation due to being at the foot of the Gevale mountain and were built in accordance with the fabric with mostly stone building material obtained from the region (Figure 3, 4).

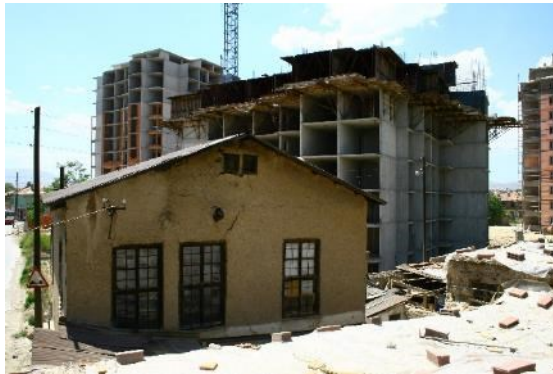
Fig. 12: Urban Transformation in relation to traditional housing, Çaybaşı Neighborhood
Source: Author (09.03.2009)

Fig. 13: Urban Transformation in relation to traditional housing, Hacı Fettah Neighborhood
Source: Author (12.05.2016)

by families with upper income status living in the neighborhoods around Mevlana tomb. However, in the future, as a result of the division among family members as a result of the death of the parents, the houses and the vineyards or gardens on which they were located were divided and sold. These houses, which changed hands, fell into disrepair, were bought by people who were not from the neighborhood, were not used, and in time they were demolished (Berk, 1951) (Figures 12, 13)

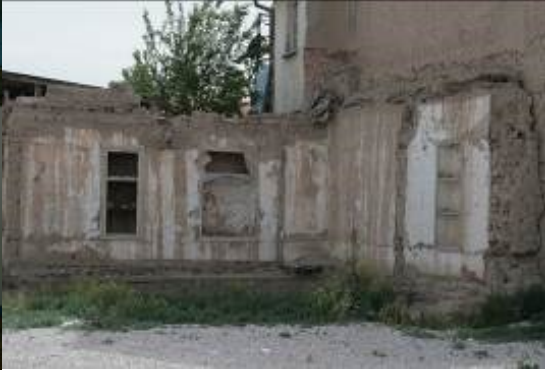
Fig. 14: Interior facade equipment elements, a house from Çaybaşı Neighborhood
Source: Author (09.03.2009)

Fig. 15: Interior facade equipment elements, a house from Hacı Fettah Neighborhood
Source: Author (12.05.2016)

The walls of the rooms are shaped with spatial equipment such as niches, *ağzıaçık*, cupboards, closets according to the condition and function of the room. The *ağzıaçık* may have names such as open cupboard niches or, in the local language, *takçagöz* and *tembel deliği*. Although spatial fittings are often designed together or alone in the space, *ağzıaçık*s are usually small in size, do not have lids and are made by combining them with other fittings with their structure consisting of shelves (Turgut, 2003). Closets are one of the most demanding accessories that require depth. For this reason, it is seen that they are constructed as a combined spatial equipment on the interior walls, on the opening surface of the room door, on a level, under the bench or on the bench (Turgut, 2003) (Figures 14, 15).
