Housing Practices in Anatolia from the Past to the Present; Traditional Konya Houses

Yavuz Arat

Necmettin Erbakan University

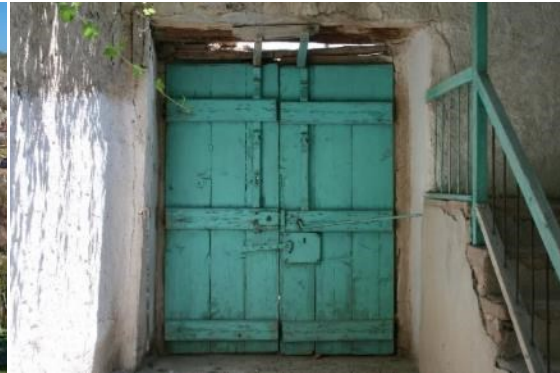
Fig. 4: Konya house courtyard/hayat gate
Source: Author

From this point of view, in traditional houses shaped by cultural codes from the past, even if the building material obtained from a widespread hinterland changes, there are no visible changes in the number of storeys and shaping in the plan scheme. In certain neighborhoods, such as in front of the tomb (around Mevlana tomb), where the housing texture shaped on a neighborhood basis is dense, the traditional understanding has continued to be maintained. A large single or double winged door opening to the part used as a road accesses at this point, the high *hayat*/courtyard wall. In this housing pattern, which is generally shaped on the flat plain, the use of storeys has developed in a similar way in this type, and forms of spatial organization have been provided with the orientation of functions and appropriate garden use. In addition to the traditional dwellings of the city, which developed in a plain area, there are also settlements in sloping areas where older settlement forms are seen, where there is a floor or level use below the ground floor level. In this settlement form, there is a formation that allows for the terrain conditions. As an example, in neighborhoods identified with the Neolithic Age, such as the Sille Neighborhood in the Selçuklu district of Konya city, the spatial organizations seen in the houses built were solved with a "slope/level" with a sloping formation due to being at the foot of the Gevale mountain and were built in accordance with the fabric with mostly stone building material obtained from the region (Figure 3, 4).

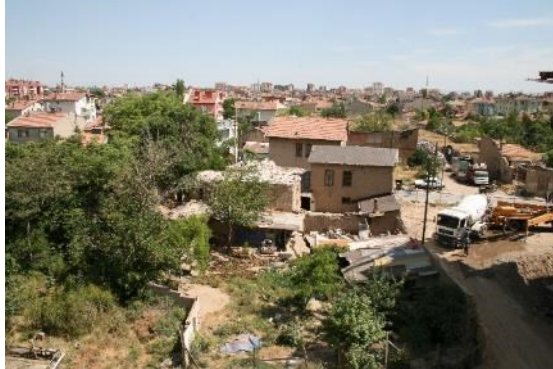
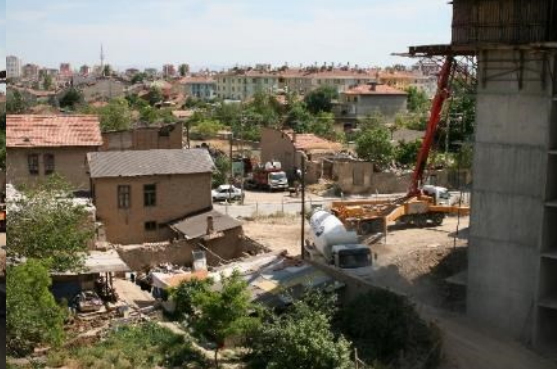
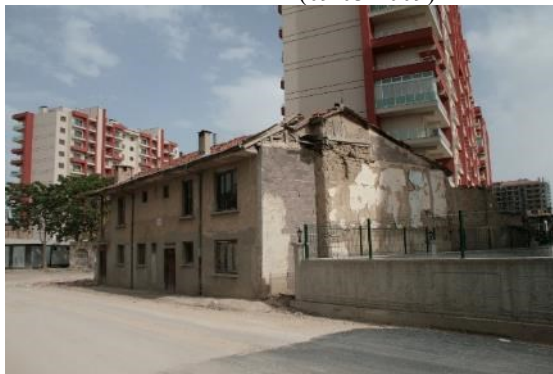
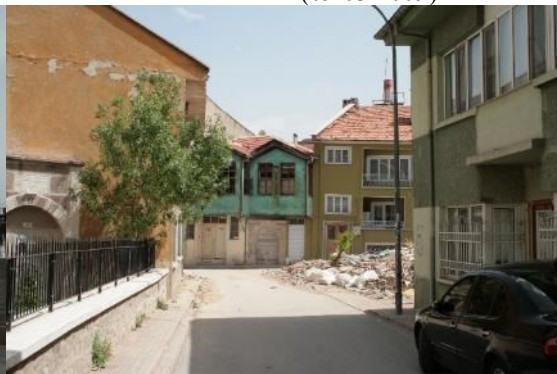
Fig. 8: Photo of Saim Sakaoğlu House neighborhood
Source: Author (09.03.2009)

Fig. 9: Photo of Saim Sakaoğlu House neighborhood
Source: Author (09.03.2009)

Fig. 10: Photo of Hacı Fettah neighborhood
Source: Author (12.05.2016)

Fig. 11: Photo of Şükran neighborhood
Source: Author (12.05.2016)

In summary, one of the leading small-scale house groups of traditional Konya Houses are the Houses with *hayat*. Houses with *hayat* have grown in plan by changing over time and within the scope of need, and have developed in different forms to adapt to the developing roads and parcels of the city (Berk, 1951). Based on the determinations in the studies carried out in this context, it is seen that traditional Konya Houses are shaped in similar ways, regardless of the different forms of *hayat* and street connection, and are produced in the same architectural understanding and structure form (Berk, 1951). Even if the *hayat* is actually used as a transitional space between the street and the house, one cannot enter the house without passing from the *hayat* to the front courtyard covered with irregular stones. At this point, the *hayat* or courtyard section is separated from the street pattern, which establishes its connection with the city, by means of its high walls. The use of the front garden/*hayat*/courtyard together with the equipment of the house on the ground floor is an indispensable area of use for the house owners, especially in the summer months. The use of the *hayat*/courtyard is seen in Konya Houses in several ways. At this point, depending on the location of the house, it is shaped in several ways in relation to the external environment/street. However, limiting it with a high wall to form the privacy area of the homeowners, thus, the formation that will ensure use at all times of the day is seen in almost all houses. It is said that what makes the difference in the formation of the house is the way in which the inward-oriented plan shapes relate to the *hayat* / courtyard rather than the street pattern, since there are rooms / sofas facing the *hayat*. In this context, the formation is generally seen in three different ways. Accordingly, single-storey, two-storey and types with *mabeyin* are commonly observed in traditional Konya Houses. In single-storey plan types, the ground floor is raised by one, one and a half or two meters to form a hut underneath, and the use of the lower floor is integrated with the hut and kitchen areas. Raising the house off the ground was done on stone foundations to provide a solid foundation for the mudbrick walls and to protect them from moisture and dampness. However, the height of the houses that have survived to the present day is no longer legible due to the change in the surrounding street pattern and the rise of the roads. Unlike the two-storey types, the ground floor and the *hayat*/courtyard floor are located together, and it is seen that the ground floor has an additional function. At this point, it was observed that one or two living spaces were built on the ground floor as well as warehouses, stables and storage units compared to the single-storey ones. The staircase to the upper floor is either inside the house or separately with a wooden staircase from the outside (Figure 8, 9, 10, 11).

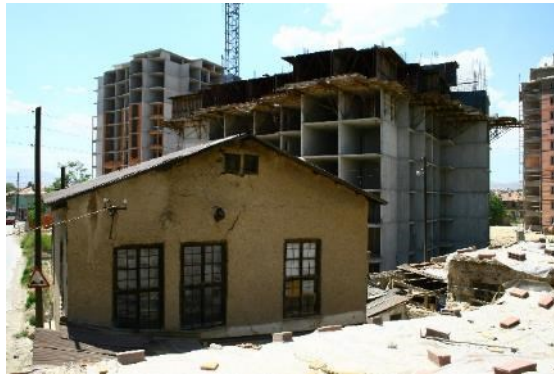
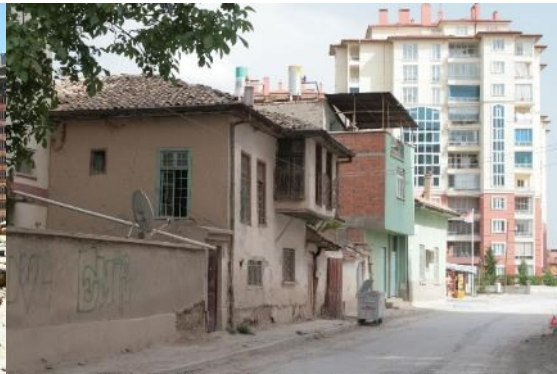
Fig. 12: Urban Transformation in relation to traditional housing, Çaybaşı Neighborhood
Source: Author (09.03.2009)

Fig. 13: Urban Transformation in relation to traditional housing, Hacı Fettah Neighborhood
Source: Author (12.05.2016)

by families with upper income status living in the neighborhoods around Mevlana tomb. However, in the future, as a result of the division among family members as a result of the death of the parents, the houses and the vineyards or gardens on which they were located were divided and sold. These houses, which changed hands, fell into disrepair, were bought by people who were not from the neighborhood, were not used, and in time they were demolished (Berk, 1951) (Figures 12, 13)

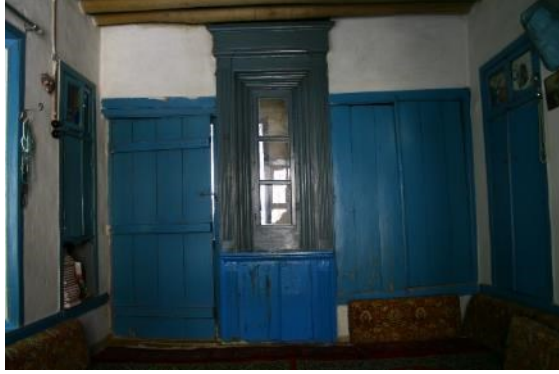
Fig. 14: Interior facade equipment elements, a house from Çaybaşı Neighborhood
Source: Author (09.03.2009)

Fig. 15: Interior facade equipment elements, a house from Hacı Fettah Neighborhood
Source: Author (12.05.2016)

The walls of the rooms are shaped with spatial equipment such as niches, *ağzıaçık*, cupboards, closets according to the condition and function of the room. The *ağzıaçık* may have names such as open cupboard niches or, in the local language, *takçagöz* and *tembel deliği*. Although spatial fittings are often designed together or alone in the space, *ağzıaçık*s are usually small in size, do not have lids and are made by combining them with other fittings with their structure consisting of shelves (Turgut, 2003). Closets are one of the most demanding accessories that require depth. For this reason, it is seen that they are constructed as a combined spatial equipment on the interior walls, on the opening surface of the room door, on a level, under the bench or on the bench (Turgut, 2003) (Figures 14, 15).
